Shared Kitchen Visit - 30 August, 2019

The following is a summary of the observations of XXXX production within their facility. This is meant to serve as a training document with all observations being called out solely for the purpose of awareness and continual improvement:

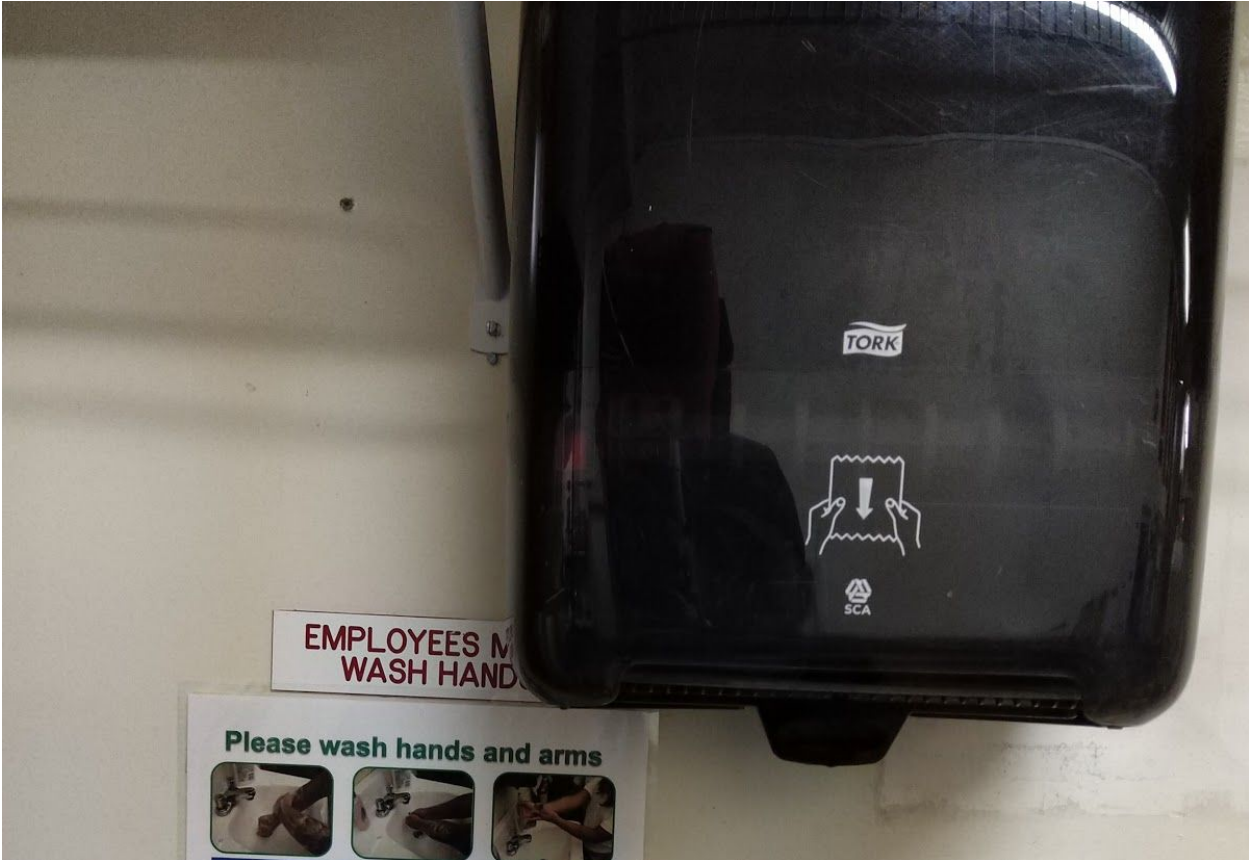
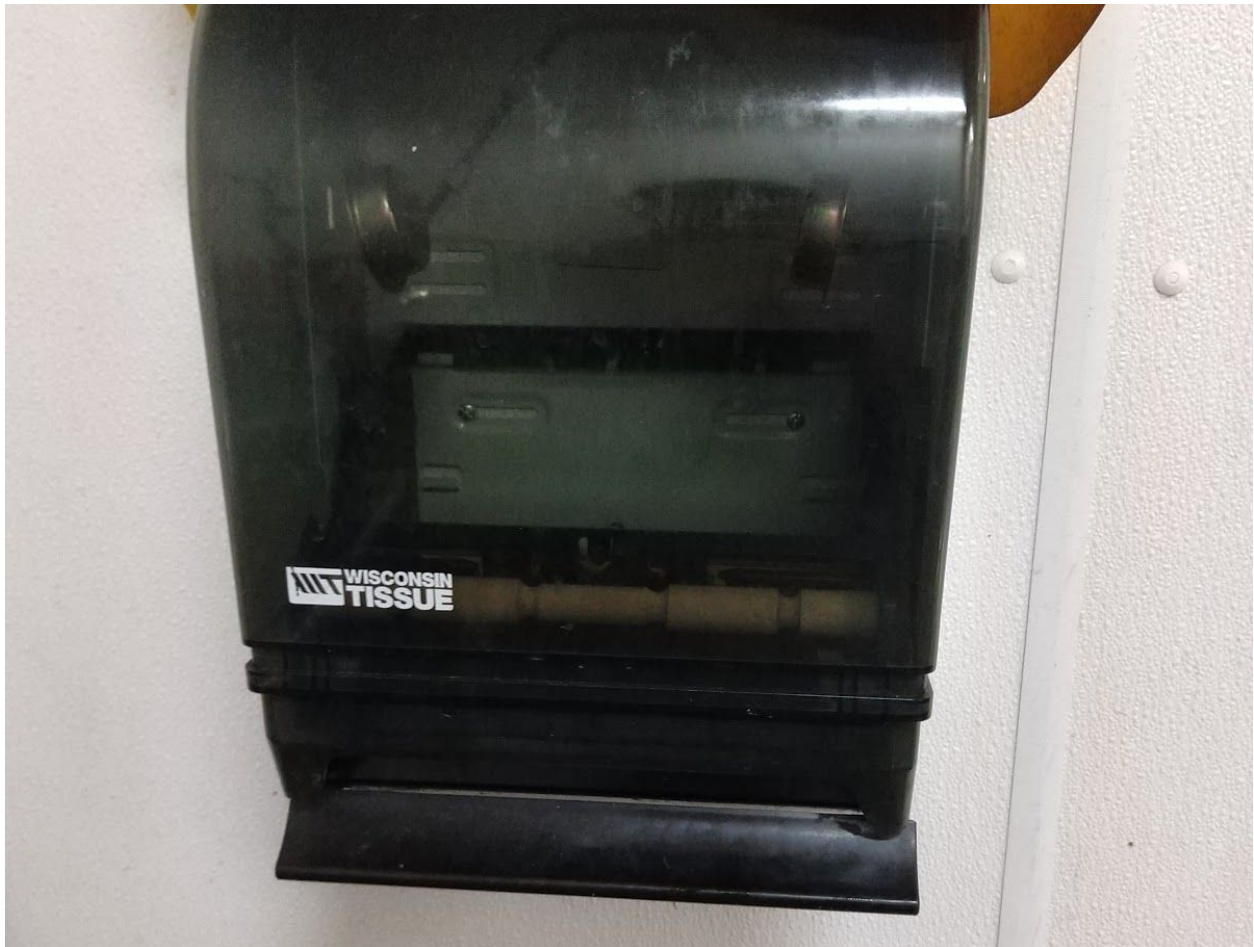
➤ **Handwashing Sinks Not Stocked**

- **Observation:** Observed the hand sink paper towel dispensers in the vicinity of the production space empty. The closest paper towel dispenser that was stocked was across the kitchen, in a back production room. Failure to provide adequate hand drying provisions will cause staff members to wash their hands less, promoting the potential for cross-contamination or unsafe food handling practices.
 - **Recommendation:** Discuss with the plan to keep the paper towels stocked with the site operator and ensure these are filled as needed to promote proper handwashing.
